ANALYSIS AND STRENGTHENING OF RC MANUFACTURING FRAME STRUCTURES DAMAGED BY EARTHQUAKE

Keywords: RC frames, earthquake damage, rehabilitation, FE analysis.

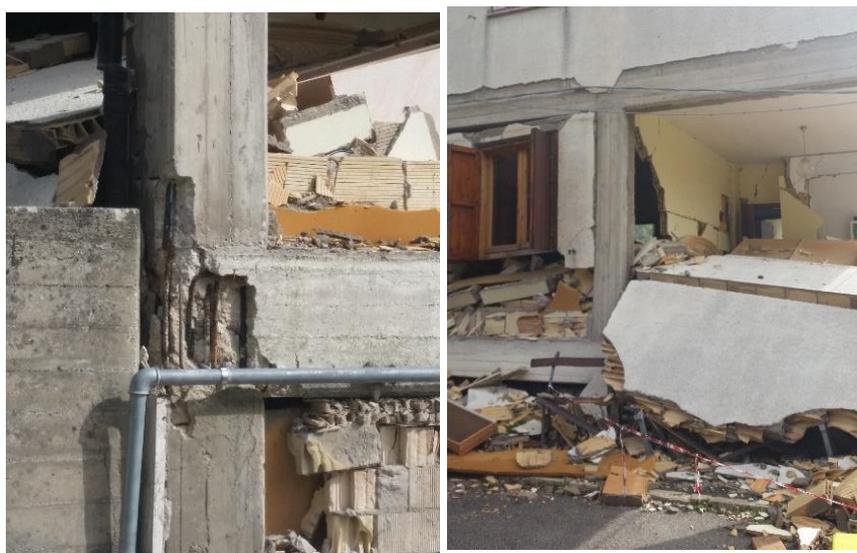
Fig. 1 – Damages in civil buildings in Arquata del Tronto, Italy (2016)

RC frames, the response to seismic actions is linked to ductility of columns under bending and shear internal forces. Many damages have been recorded in civil buildings during recent earthquakes built with for RC frame structures and infilled masonry walls; dangerous damages interested column/column-beam nodes (Figs. 1(a),(b)). In this paper one study and strengthening of RC frames of a large manufacturing buildings located in small town of Matelica, damaged by recent earthquakes in Italy, have been analysed (Fig. 2). RC structures of manufacturing buildings were built in different past periods so that some buildings were not designed to resist to earthquake and therefore collapse has interested some part of industrial building. Main damages have interested however many elements of the RC structures both roof and columns together with beams and nodes of same RC frames. The study has been developed starting from the damages of frames and the collapse that has affected a part of buildings with RC frames and structures built in the seventies of last century utilizing an old Italian Code of Practise with few rules regarding the seismic actions. Because of the weakness of many RC structures, an investigation of concrete and steel bars used in the construction of RC structures has been considered as mostly important to define the elements with reduction capacity and need of strengthening. Although many non-destructive tests may be considered useful [6], in this investigation many specimens were subjected to compressive and tensile tests.

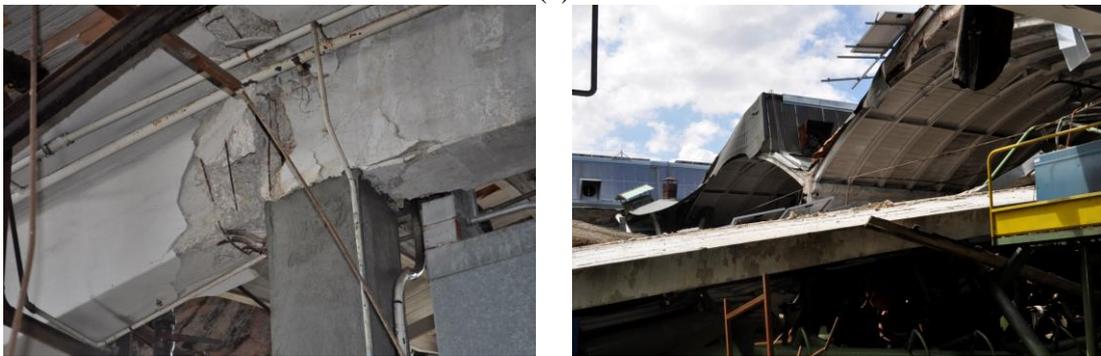
It is clear that seismic actions' intensity is very high (Fig.5), in particular on the east-west direction. Under the 30 August 2016 earthquake's action, some buildings of the industrial complex (Figs. 6(a), (b)) – object of this analysis – have suffered serious damages with structural collapse for some parts, as indicated in Figure 6(b).

Fig. 6 – (a) Plan of industrial buildings and collapsed zone; (b) details of damages.

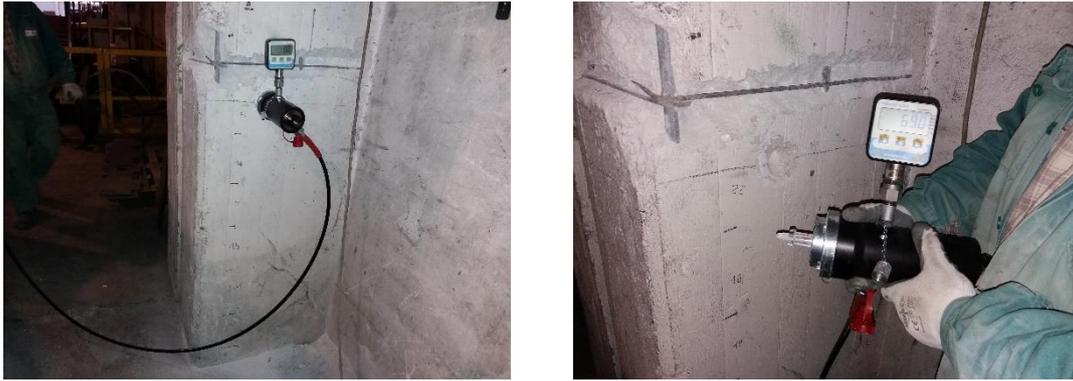
An electronic magnetometer produced by Elcometer “Inspection Equipment”, model P331H, was used for the detection, equipped with an acoustic and visual check for the location and disposal of the reinforcement bars; pull-out tests on the columns and RC beams were used to evaluate the resistance of the concrete (Fig. 7).

Fig. 7 - Pull-out tests on RC columns
